Sustainable Resilient Flooring Choices for Hospitals

Perceptions and Experiences of Users,
Specifiers and Installers

DECEMBER 2010

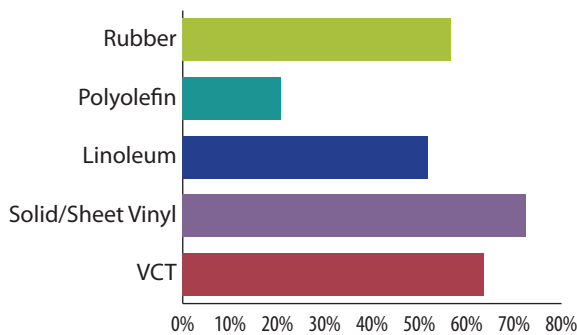
Figure 2: Resilient Flooring Adoption Rates

Although rubber, linoleum and polyolefin flooring materials have been increasingly featured in media and magazines, it was important to better understand the adoption rates within the healthcare industry compared with the use of the traditional vinyl products. From all survey respondents, we saw the greatest use of the two vinyl products. Sheet vinyl is the most commonly used product (73%), followed by VCT (64%). This finding is consistent with our preliminary research, which found that VCT has the lowest first cost, followed by sheet vinyl, and that both products have a long history of use in healthcare. Over half of the respondents reported having specified, used or installed each of the two newer product offerings, rubber (57%) and linoleum (52%). The survey found that there was much less familiarity with polyolefin (21%) and even less with rubber/cork flooring (14%). Because of the low adoption rate for rubber/cork, the material was not included in our case study research and no further results are reported in this paper. See Figure 2 for the adoption rates of all the flooring materials for all the survey respondents.

Over half of the survey respondents reported having specified, used or installed two of the more sustainable product offerings, rubber (56.7%) and linoleum (51.8%). We found that there was much less familiarity with polyolefin (20.7%). Across all survey respondents, we saw the most use of the two vinyl (less sustainable) products; sheet vinyl is the most commonly used product (72.5%), followed by vinyl composition tile (VCT) (63.6%).

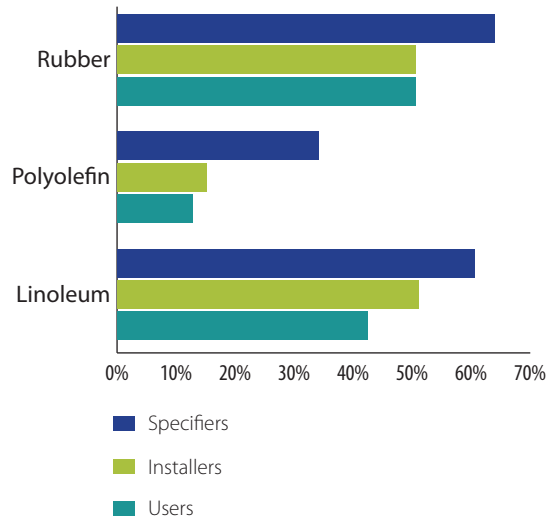
Figure 3: Resilient Flooring Adoption Rates by Material and Stakeholder Type

If we break down the adoption rates by respondent type, we see that architects had higher adoption rates for all materials, see Figure 3. While architects may have had several healthcare clients throughout the years with diverse flooring needs, facility managers are typically responsible for one institution with a limited palette of flooring materials and installers tend to specialize in material.

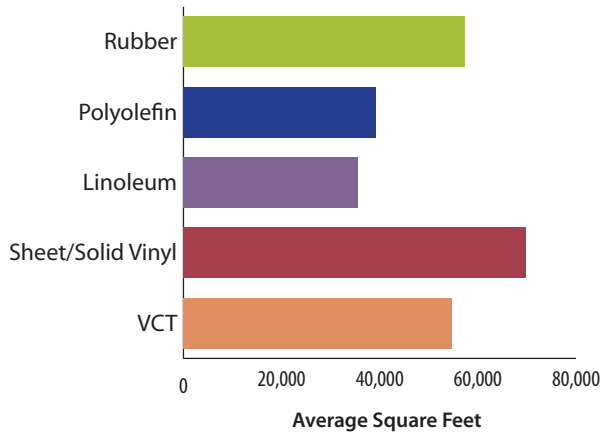
Figure 4: Resilient Flooring Square Footage by Material

Survey responders who classified themselves as architects/specifiers were asked to quantify the average amount of each resilient flooring material they had used per project. About half of respondents were not able to specify an amount, marking the “Don’t Know” option. From the results collected, we found that solid/sheet vinyl was used to cover the largest amount of floor space, see Figure 4. Interestingly, rubber surpassed VCT in square feet, which could be a reflection of an industry trend. Alternately, the results could have been swayed by targeted marketing of the survey to early-adopters, reflecting a trend in these users, but not the industry as a whole.

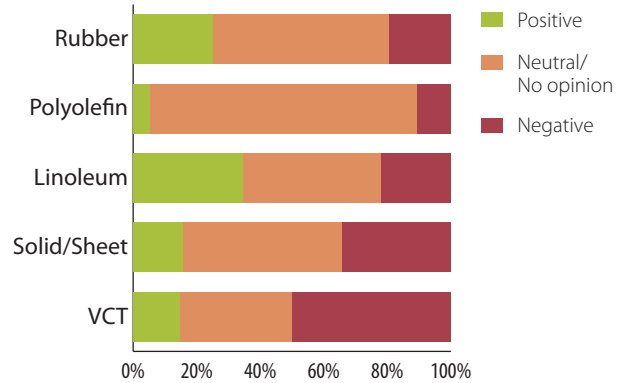
Figure 5: Perception of Resilient Flooring Materials by People that Have NOT Used It Before

Figure 5 shows the opinions of all the survey respondents regarding the materials that they have not used recently. Linoleum and rubber are both perceived positively by many of the people surveyed (35% and 25% respectively). Results indicate that people are not generally familiar with polyolefin; 84% of respondents said they were neutral or had no opinion about the product, and only 5% had a positive impression of the material. Both vinyl floor covering products got the most negative ratings from people who are not using the materials, with 50% of people having a negative opinion of VCT and 34% for solid and sheet vinyl. It seems reasonable to conclude that this perception is driven by the negative environmental image of the products and an understanding of the health risks highlighted in the “Resilient Flooring & Chemical Hazards” report.

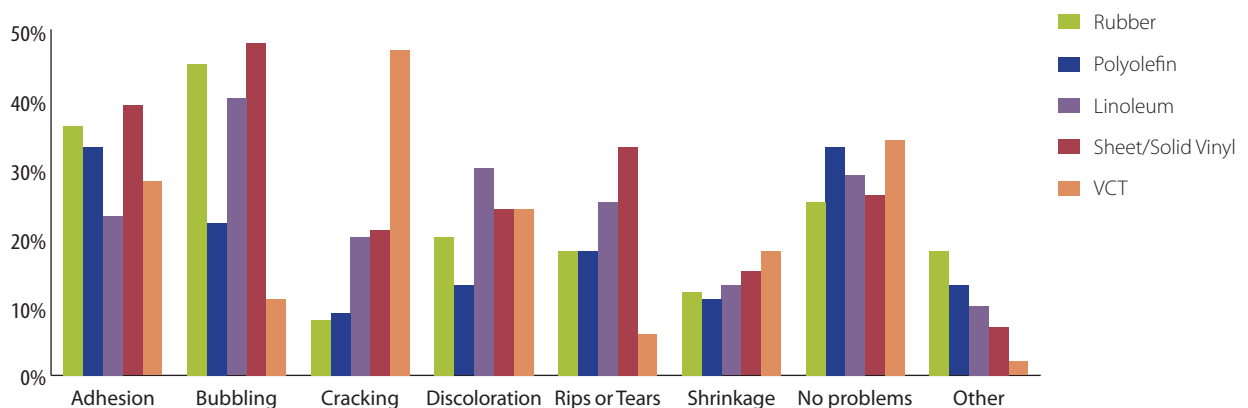
Figure 13: All Resilient Floors Experience Installation Problems

Although problems with installation may be attributed to specific flooring types, adhesives or the installer, the overall trend is that all materials, including the vinyl ones, are experiencing installation problems. From the case study interviews we learned that the incidence of flooring failures is generally not due to properties of the materials, but result from a combination of factors that have converged at the same time that these materials have become more commonplace in the market. Speeding up the construction cycle has resulted in compressed schedules which do not always allow adequate time for the slab to cure prior to flooring installation. The adoption of new formulations of concrete, particularly lightweight or porous formulations and those including fly ash, has also resulted in slow curing slabs or surfaces that do not react well with adhesives⁸. Another factor that has affected floor installation is the shift to low-VOC adhesives. These adhesives are better for the health of the installers and occupants of the space, but they are also more temperamental to work with when compared to old adhesives. The low-VOC adhesives can work as well as the adhesives they replaced, but they require more planning and skill on the part of the installers, who have to schedule their work around the open time for the adhesives.

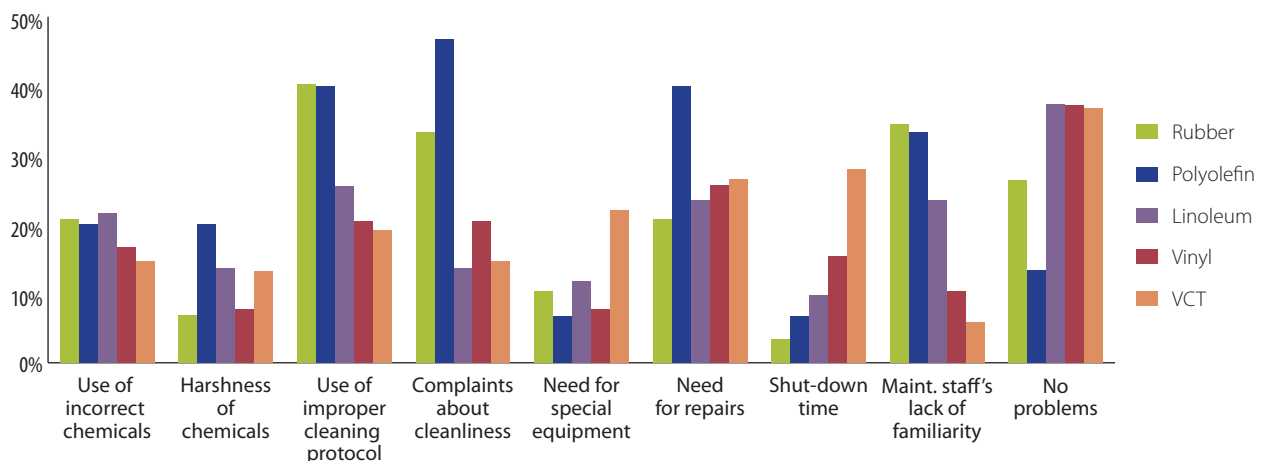
Figure 14: Lack of Familiarity Results in Improper Cleaning

We also provided a specific list of maintenance problems in the survey for users and asked them to select all of the problems they had experienced with each of the materials they had used. The full results are provided in Figure 14. In keeping with the case study comments about the cleaning requirements for VCT, the survey shows more people reporting problems with shut-down time for VCT. Other notable results are that polyolefin stands out, with more needed repairs and complaints about cleanliness. We did see greater incidence of using the wrong cleaning protocol for the three non-vinyl products, which seems to go hand-in-hand with the higher reports of maintenance staff's lack of familiarity with the products.

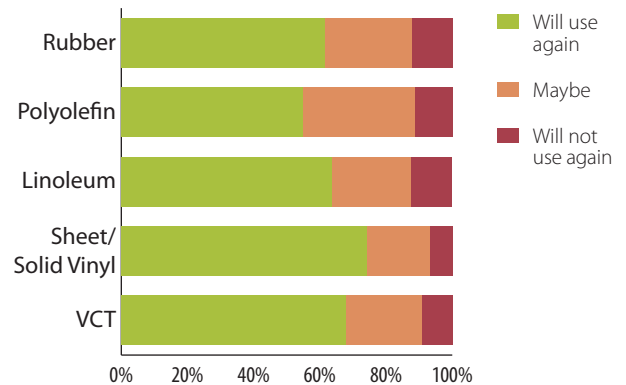
Figure 15: Experienced Stakeholders Expect to Continue Using All of the Resilient Flooring Options

The intention to use a product in the future is an important indicator of how well these flooring products have performed in hospitals and whether or not they will continue to grow their share of the market. In the survey we asked people that had used a material how likely they were to use it again. Response options were ‘definitely,’ ‘most likely,’ ‘maybe,’ ‘not likely’ and ‘definitely not’. We grouped the answers on the two ends of the spectrum to make the data easier to interpret. What we can see in Figure 15 is that over 85% of people who have used the three green alternatives are open to using them in the future, and over 50% of those people will most likely use rubber, polyolefin and linoleum again. Respondents also indicated that they were likely to use sheet/solid vinyl and VCT in the future. This is consistent with our analysis in the sustainability section that found that people that had used the vinyl products in the last five years were likely to continue using them in the future. The important message is that architects, installers and facility managers who have experience with rubber, polyolefin and linoleum were pleased enough with their experience to use these products again in the future. This should be reassuring to hospital stakeholders considering using one of these materials in a project.

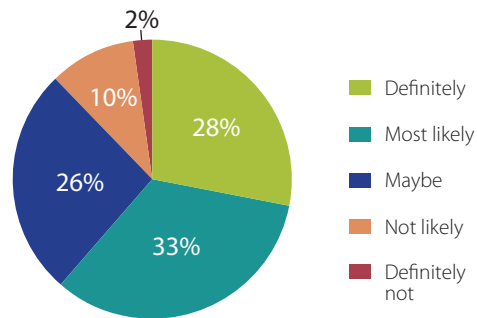
Figure 16: Continued Use of Rubber Very Likely

When we asked specifiers and facility managers who had used rubber flooring whether or not they expected to use it again in the future, 61% of them answered definitely or most likely. See Figure 16 for a combined summary of the responses from architects and users. We also asked architects who had not used rubber how likely they were to specify rubber in the future, to get a sense of any trends. A full quarter of these architects said they were definitely or most likely going to specify rubber in future projects, and 53% responded that they might specify rubber in the future.

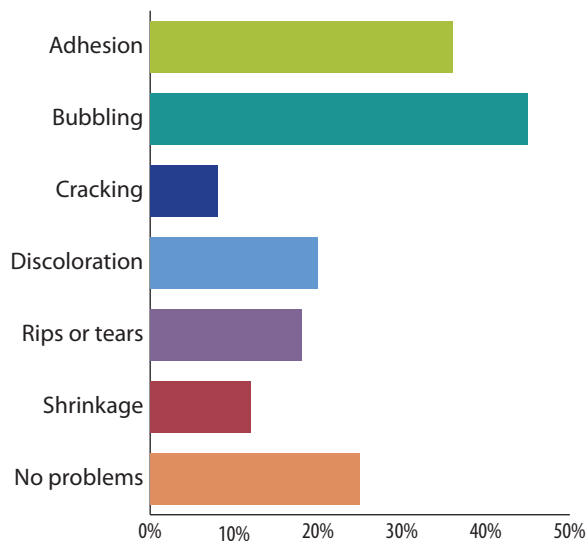
Figure 17: Bubbling and Adhesion are Biggest Installation Issues for Rubber

As we expected from the previous research project's case studies, bubbling was the most widely reported installation problem, experienced by 45% of all respondents. Adhesion was also a common problem, experienced by 36% of respondents. People interviewed for the case studies and background research did not report having major problems with bubbling or adhesion. It was universally felt that any problems experienced with rubber flooring installation were common to all resilient flooring materials and were more due to surface preparation and newer adhesives than something inherent in the rubber flooring.

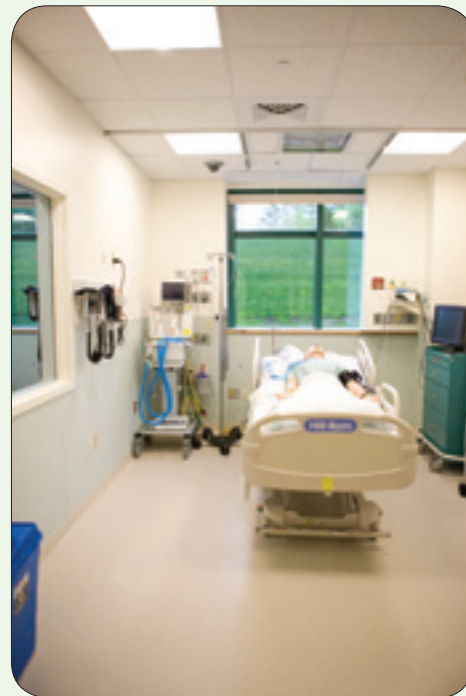
Photo courtesy of Lavelle Brensinger Architects

In May 2008, when it came time to renovate a space to create an 8-bed Intermediate Care Unit, Dartmouth Hitchcock decided to outfit the entire 4,000 square feet unit with Mondo rubber sheet flooring with welded seams. Staff of the ICU requested rubber because they had heard good things about rubber flooring in terms of comfort and acoustics. Before making the final decision, the Center brought in the vendor, Mondo, to talk with clinicians and housekeeping staff to make sure they understood that the floor would not be as shiny as they were accustomed to with VCT.

As was expected, there was some initial resistance from those who thought the rubber floor didn’t look clean because of the lack of shine. However, over time the rubber floor has matured and become shinier, developing a natural luster as a result of auto scrubbing. As the material matures, the floor requires less scrubbing. One nurse in particular prefers the lower gloss floor because the rubber floor does not produce glare which can exacerbate her migraines. In addition, the Center had previously received complaints that waxed vinyl floors were too shiny and looked slippery. Staff find the cleaning of the floor to be much less disruptive than the cleaning process for VCT (where areas needed to be off-limits for cleaning), as well as having a less noxious smell. Cleaning staff uses a small auto scrubber that allows them to maneuver around in the patient rooms and occupied areas. Perhaps the most challenging procedure change they have faced has been getting the cleaning staff to use the auto scrubber for discharge cleaning instead of mopping. The auto scrubber provides better results, whereas wet mopping alone can result in a film residue left on the surface. The resistance to using the auto scrubber for discharge was likely just because it was a change in process and required the staff to retrieve the equipment when needed; it has not proven to be a big issue.

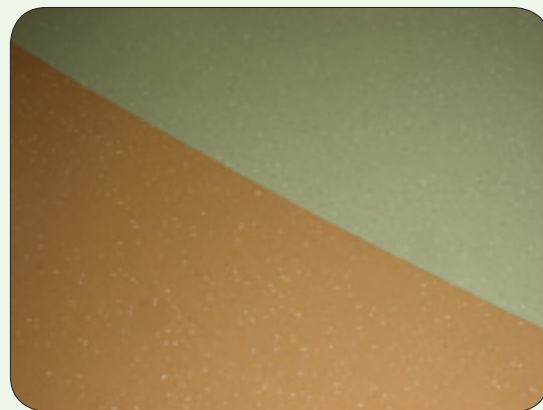
Photo Courtesy of Gundersen Lutheran

Gundersen Lutheran's main hospital in La Crosse has installed approximately 3,000 square feet of rubber flooring in the ICU, nurses' stations, and in the trauma and emergency department. They experienced some staining and discoloration problems in the initial installation in the emergency department, which was due to a previous formulation of Nora rubber flooring. They have not had any issues with subsequent installations, and although Nora offered to replace the defective product, the hospital chose not to have the flooring replaced because it would disrupt operations. During installation of the rubber flooring, they found that the two-part epoxy has a strong smell and dries rapidly, requiring quick response on the installer's part. One solution was to use smaller quantities; they found that 1-gallon containers of the epoxy worked better than 5-gallon containers because it did not require them to work as large an area at one time. Despite these drawbacks, the epoxy provides better results than the adhesive. Another lesson is that it is important to give adhesives time to dry before subjecting the floor to traffic. If carts or equipment are rolled over the floor before the adhesive hardens, they can leave grooves in the floor that collect dirt.

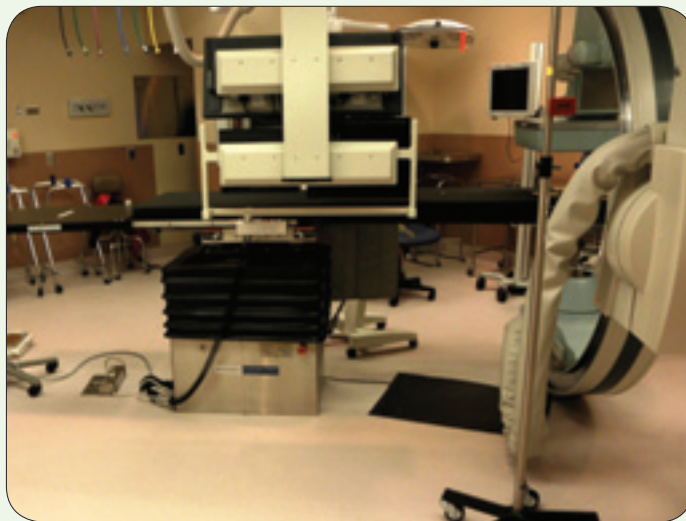
Photo courtesy of Northern Michigan Regional Hospital

In 2009, Northern Michigan Regional Hospital renovated one of their 550-square-foot operating room suites and decided to replace the old sheet vinyl with Estrie's Duramed rubber flooring. As part of the decision process, they marked up a sample of flooring with different stains and asked for feedback from the housekeeping staff on how well it cleaned up. Housekeeping was impressed that all of the stains, with the exception of the surgical marker, were easily removed from the rubber flooring.

Occasionally, the auto scrubber is used on stubborn stains such as Betadine®. The maintenance requirements are so simple that the staff didn't require any special training; the most challenging aspect is to remind the staff that they *don't* need to strip and wax the floor. Even with this reduced maintenance, the rubber floor looks great and is developing a natural luster. Based on their experience in the single operating room, the facility coordinator for Northern Michigan Regional Hospital anticipates that they will use rubber in future operating room applications that call for a sheet product. ■

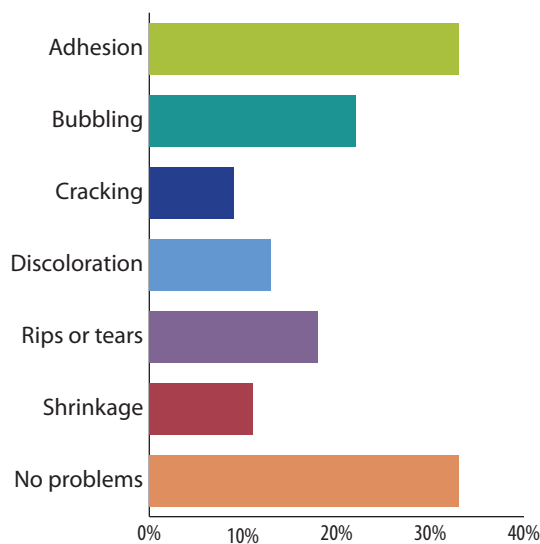
Figure 20: Adhesion Most Common Installation Problem with Polyolefin

During the case study interviews, people spoke mostly about adhesion problems, and a third of the survey respondents reported having adhesion problems with polyolefin as well. Mass General had poor adhesion in the installation of their polyolefin floor that caused some tiles to pop up. They felt that the product requires more skill to install than VCT and suggest looking for installers with prior experience working with polyolefin. The Allina Hospital system had a lot of problems with tiles popping up and concluded that it was caused by the quick set adhesive that they used for their renovation projects. While 22% of the people surveyed said that bubbling was a problem, it was not brought up during the interviews. As a tile or plank product, it is unclear how polyolefin products can bubble; it is possible that the survey results are skewed by some survey participants confusing polyolefin with other flooring products. It should also be noted that a third of the people surveyed reported having no installation problems with polyolefin.

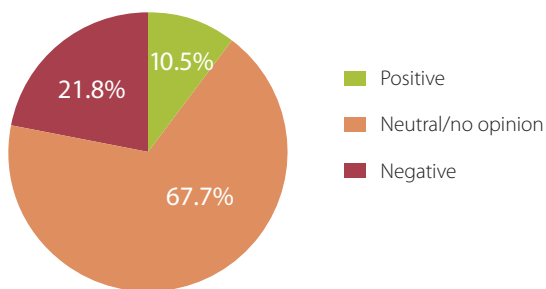
Figure 21: Opinion of Non-Users for Polyolefin is Largely Neutral

We asked architects if polyolefin met their performance expectations, and 69% said yes; they also reported that 81% of their clients were satisfied with the material. Of the survey respondents who had not used polyolefin in the last five years, 84% said they had either a neutral or no opinion about polyolefin - see Figure 21. Whereas only 11% had a negative opinion, the smallest percentage to have a negative opinion of a flooring material that they hadn't used, polyolefin also had the lowest percentage of non-users with a positive opinion about the material (5%); it appears that the product is simply not well-known and low usage rates are due to lack of knowledge about the product, not because of any specific perceptions about it.

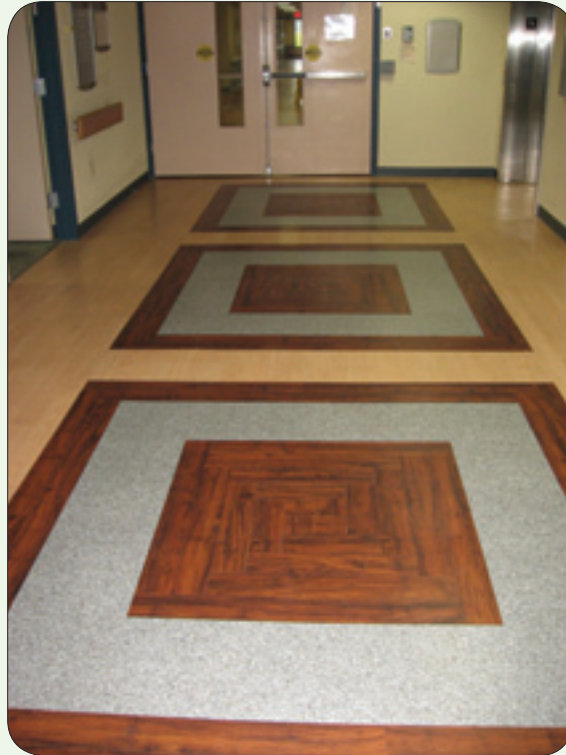
Photo Courtesy of Gundersen Lutheran

Gundersen Lutheran Medical Center installed between 2,000-3,000 square feet of Stratica in the hallways of the post-partum unit and in elevator lobbies of the Main Hospital in La Crosse, Wisconsin in 2007. They selected Stratica because of its non-institutional aesthetic and because they felt it was more sustainable than the similarly styled vinyl alternatives. The fact that it was PVC-free and could be cleaned with mild cleaners was also attractive. The Stratica comes pre-finished, so the maintenance protocol is simply to dry and wet mop with a mild soap and water solution. Areas with more traffic are auto scrubbed. The nurse manager in the post-partum unit is pleased with the new Stratica flooring, in part because the cleaning regime is more user friendly than the previous floor. They used to have carpet in this area, and the smell from the carpet cleaning process was so bad that one staff member would routinely get headaches and have to leave on days when it was cleaned. While the Stratica is not very shiny, the staff got used to the matte finish and like how it looks.

The Medical Center chose Stratica as their standard product for high traffic public areas that don't require sealed seams, such as high traffic corridors, elevator lobbies and elevator cabs. One thing they learned during installation is that it is important to make sure that the seams are tight - otherwise they collect and show dirt. Although aesthetics was a main driver for the selection of Stratica, the interior design team is frustrated by the limited variety of colors and patterns available. Another drawback reported was that the floor can be somewhat slippery when wet or when sand collects on it in the winter months. Despite this, there have not been any falls attributed to the flooring. ■

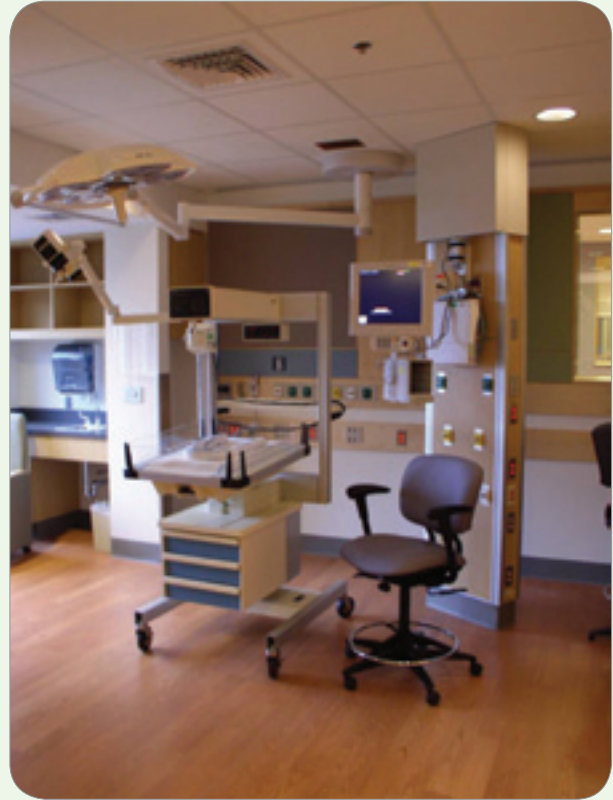
Photo courtesy of MGH Planning and Construction Office

While they are happy with the Stratica in both settings, they are more satisfied with the look of the floor in the NICU because of a couple of design-related decisions. In the NICU they used a darker color, based on feedback from the staff in the Special Care Nursery, and find that it doesn't show scuff marks as much as the lighter color does. In addition, they specified random length planks, which produces a more organic look.

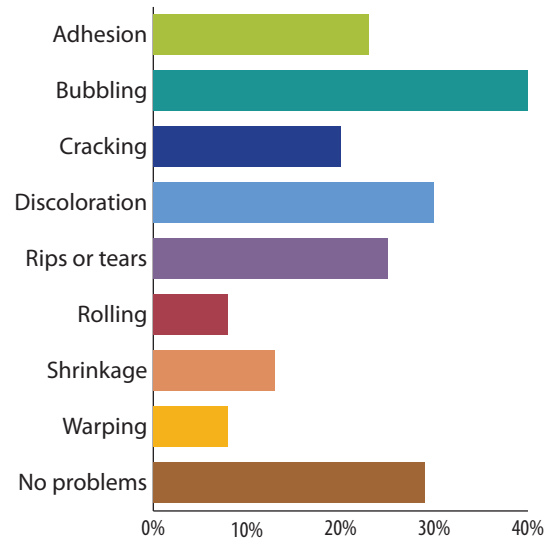
Figure 23: Bubbling Most Common Installation Problem for Linoleum

As a sheet good, the most commonly reported installation problem for linoleum in the survey was bubbling; this was not mentioned by any of the case study interviewees, so we do not have any lessons learned to report. Discoloration was identified as a problem by 30% of the survey respondents. There was a case of linoleum becoming temporarily discolored at Rumford Hospital, but they understood that this was a temporary condition caused by light exposure.
